#### Findings - Infrastructure

In the southwestern area, (Cabo Rojo) the most affected fishing area was La Mela.

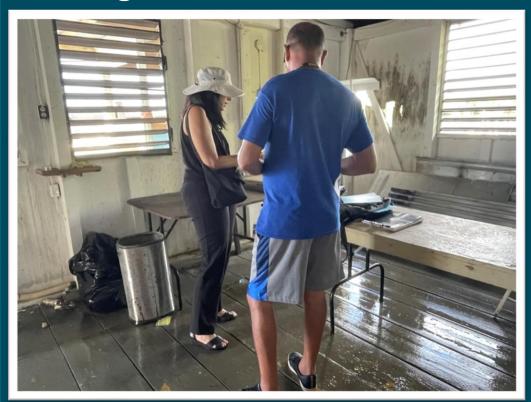
The wet floor in La Mela fishmonger is a testimony of the roof conditions after a rainy day.

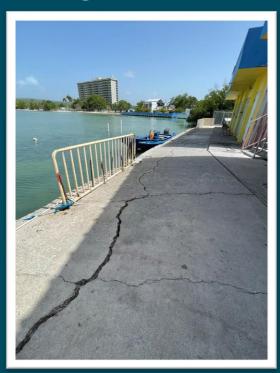
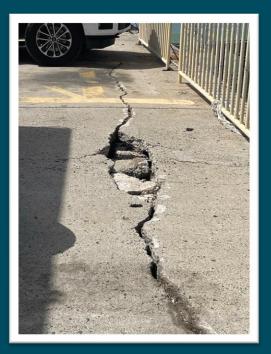
### Findings – Infrastructure – Guánica

At Playa Santa, the platform around the fishing village was severely cracked as a result of the swell caused by Fiona.

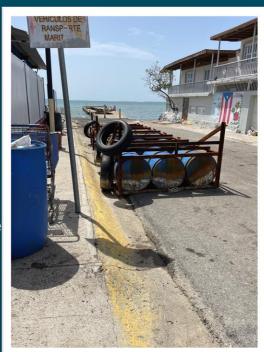
South Coast Peñuelas – Santo Cristo de la Salud

The Peñuelas fishermen's association (Santo Cristo de la Salud) in the El Boquete Sector did not suffer structural damage. However, since the impact of Hurricane María, fishermen have been deprived of a safe dock, as you will see in the following video.

They had managed to have a floating dock built for them on drones, but it was damaged and useless with Fiona's impact.

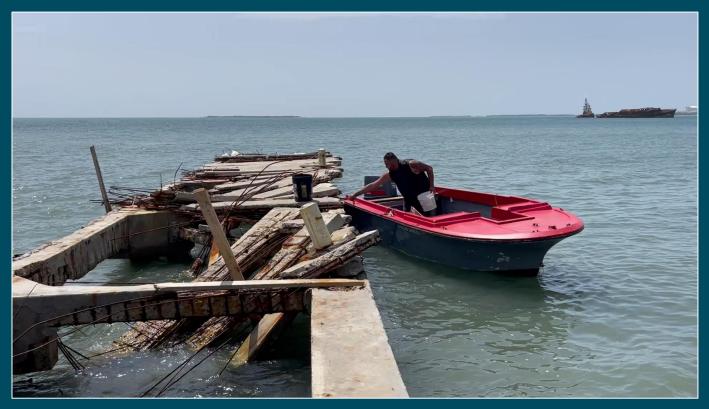
## Findings – Infrastructure – Aguirre in Salinas

The pier that you can see in the photo no longer exists since Hurricane María.

Fiona raised the roof of the buildings, which had already been affected since Maria. In the same way, the "escamadero" was left in the open without a roof.

There is a ramp that is uneven in relation to the beach, making the process of putting the boats at sea a hard and difficult one.

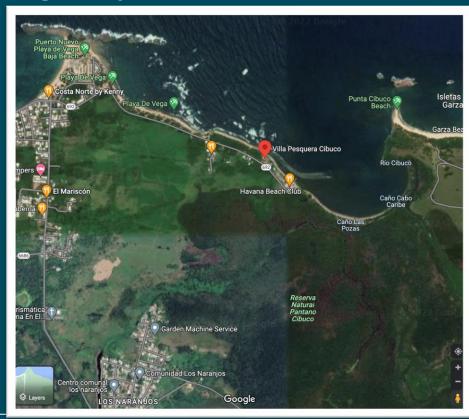
## North Coast – Cibuco – Vega Baja

This fishing village shares its ramp with recreational fishermen and with FURA. It was covered with sand, and the pier was in terrible condition.

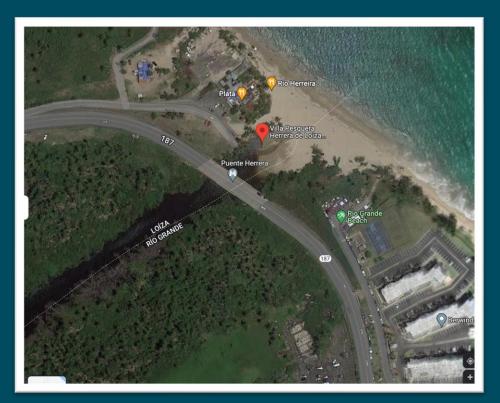
North coast - Loíza

"They came to remodel the villa, they started and left everything lying around and they haven't been back for months."

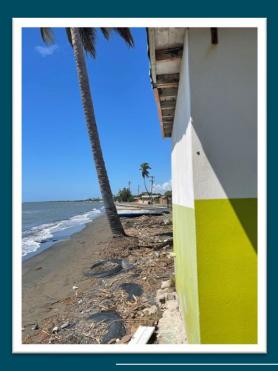
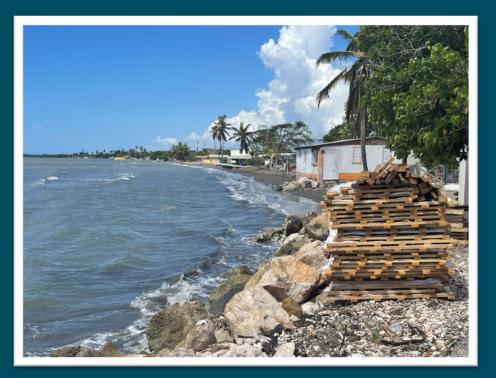
Coastal erosion in Juana Díaz

In both places, the sea entered the facilities during the passage of Hurricane Fiona. You can see the loss of beach and the space occupied by buildings near the coast.

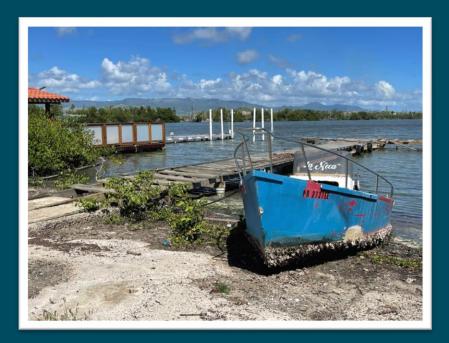
Las Mareas – Salinas

Closed since 2014

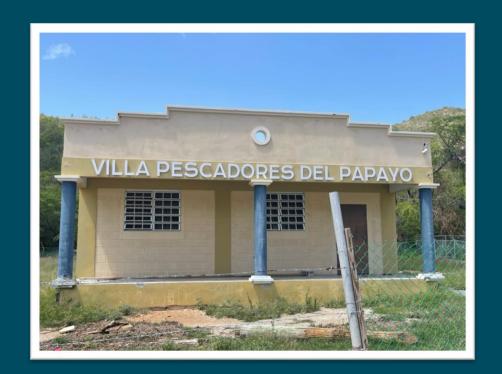
Papayo – Lajas

Even though it is an area of fishermen who report their catches and who have the facilities of a dock built by them, the building that would house the fishermen's association has remained closed and in disuse for years. It does not have water or electricity facilities, nor permission for them to use it.
